AT13-018

September 10, 2013

2013 – 2014 JX/QX60; JUDDER DURING LIGHT ACCELERATION

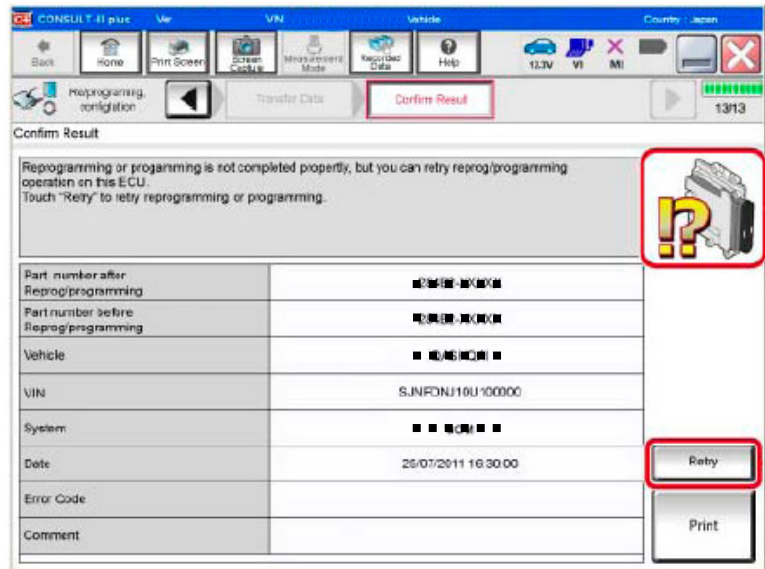
Figure 5

If reprogramming does not complete and the “!?” icon displays as shown in Figure 5:

- Check battery voltage (12.0–15.5 V).
- Ignition is ON, engine OFF.
- External Bluetooth® devices are OFF.
- All electrical loads are OFF.
- **Select retry and follow the on screen instructions.**
- “Retry” may not go through on first attempt and can be selected more than once.

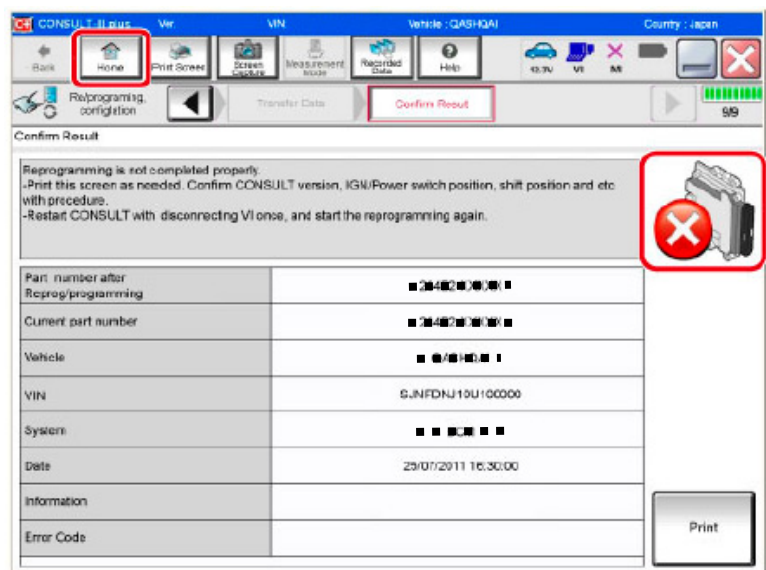
Figure 6

If reprogramming does not complete and the “X” icon displays as shown in Figure 6:

- Check battery voltage (12.0 – 15.5 V).
- CONSULT A/C adapter is plugged in.
- Ignition is ON, engine OFF.
- Transmission is in Park.
- All C-III plus / VI cables are securely connected.
- All C-III plus updates are installed.
- **Select Home, and restart the reprogram procedure from the beginning.**

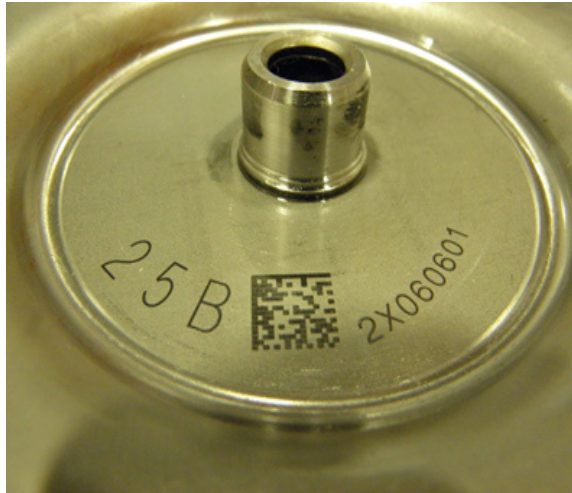
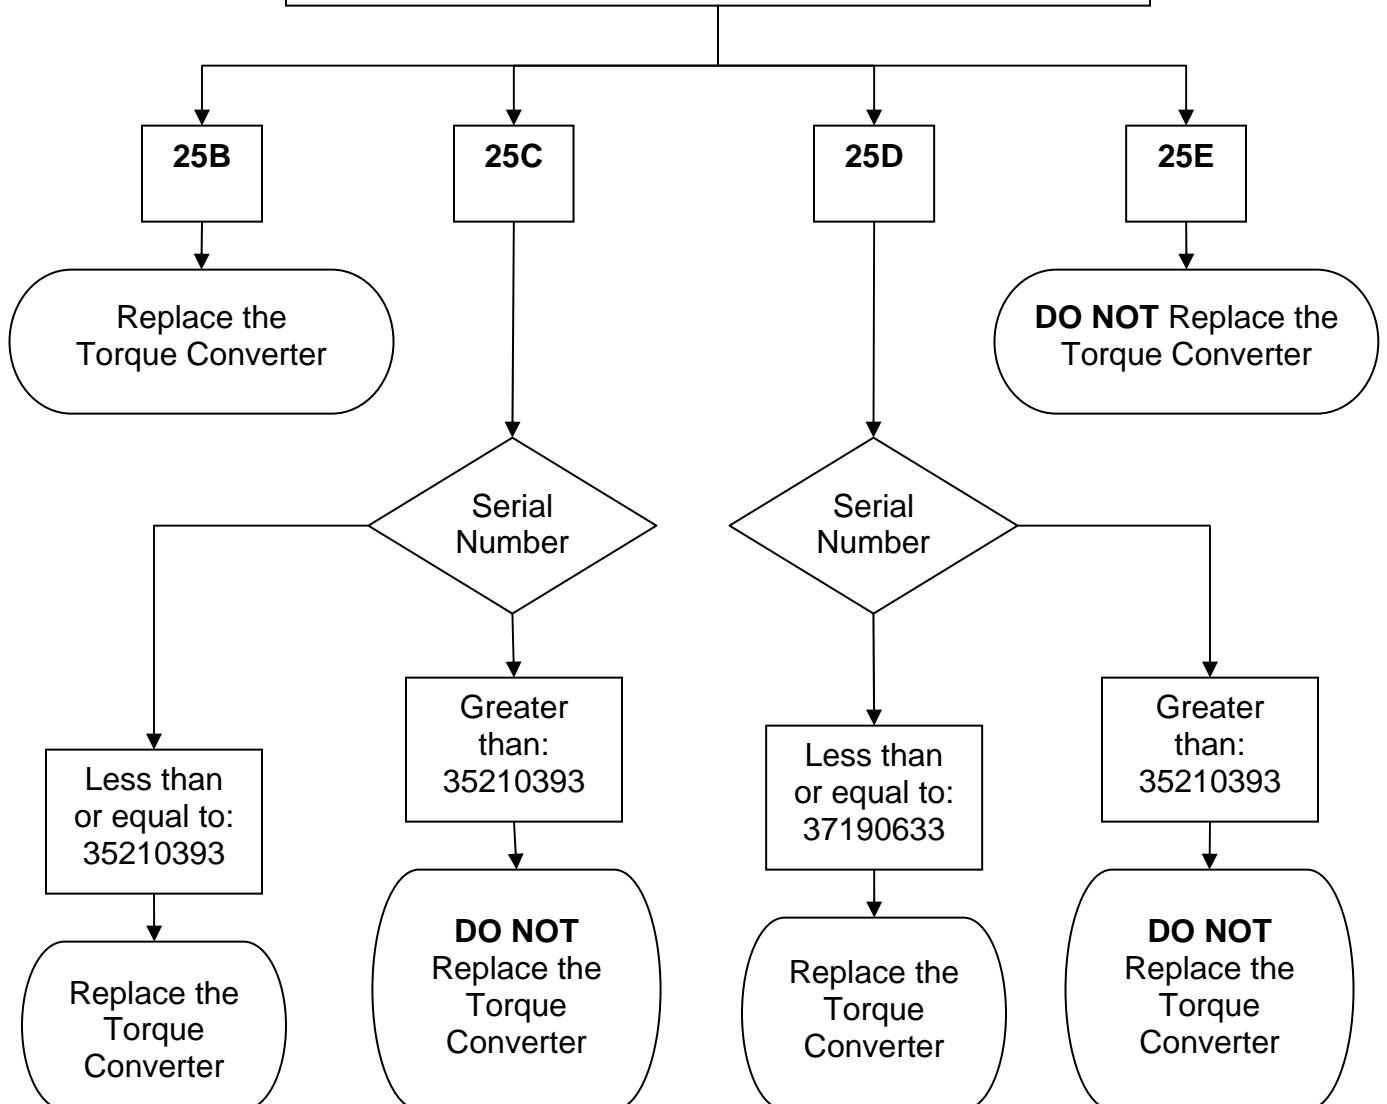
FLOW CHART B

- If a judder is present, recorded data review does not indicate pressure vibration and the torque converter in the CVT is already "D" level or greater (see **FLOW CHART B** on page 17), refer to ASIST or the appropriate section of the ESM for further diagnostic assistance.

Check the stamping on the outside of the torque converter

1. Replace the torque converter with the new one listed in the Parts Information:
